# ***Passmore Contracting Inspections***

## **Property Inspection Report**

1234 Sample Rd, Sample, VA 22222  
Inspection prepared for: Brian Passmore  
Date of Inspection: 10/27/2013 Time: 0900  
Age of Home: 2001 Size: 1960  
Weather: Clear 40 Deg.  
\$350 Paid Cash

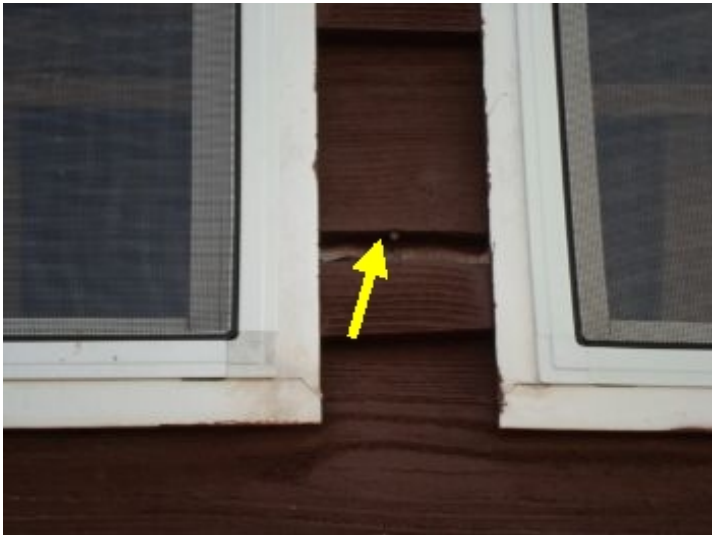
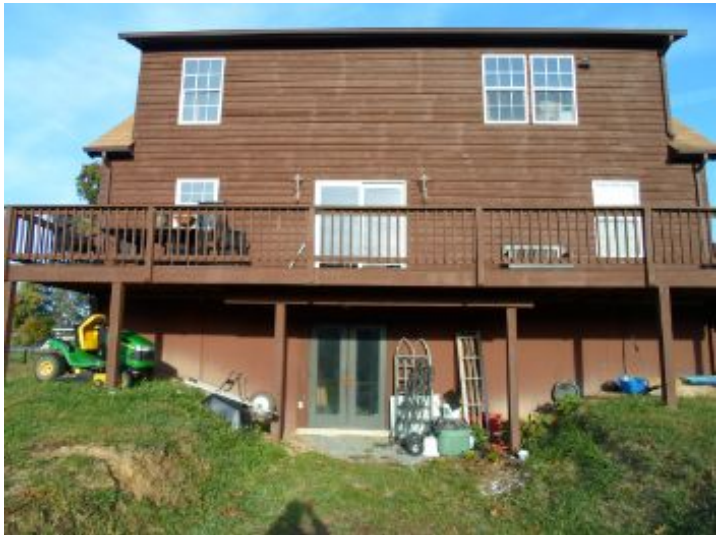
deteriorated materials needs to be maintained with caulk and sealer.

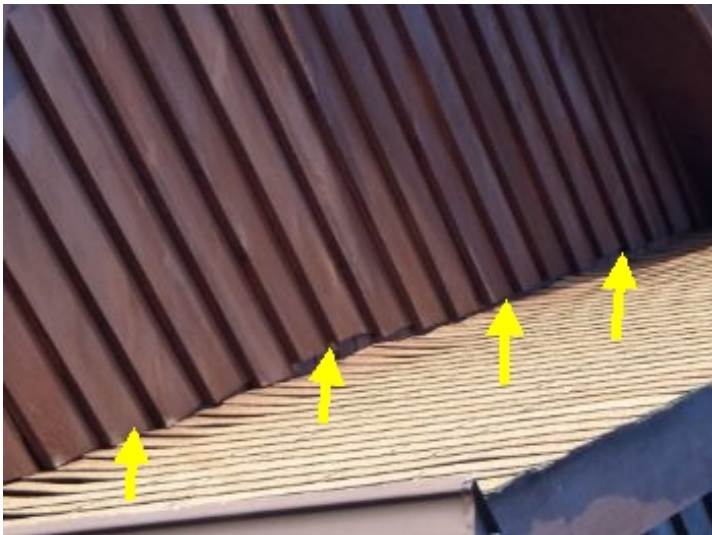
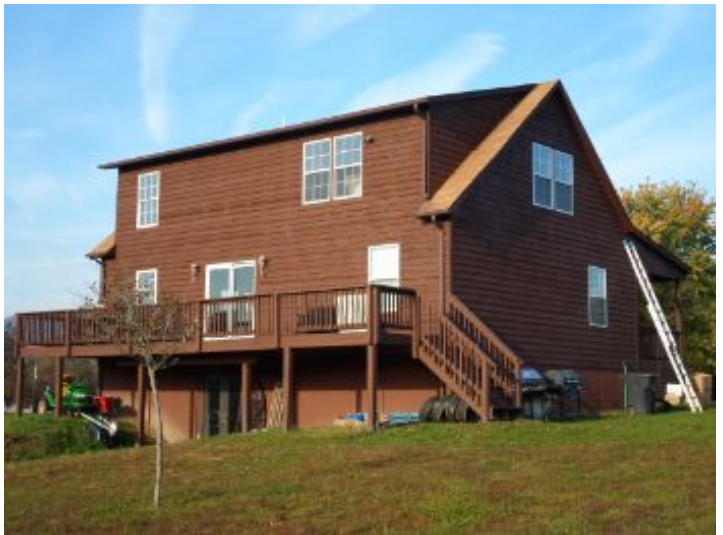
Uneven gaps going up the roof line.

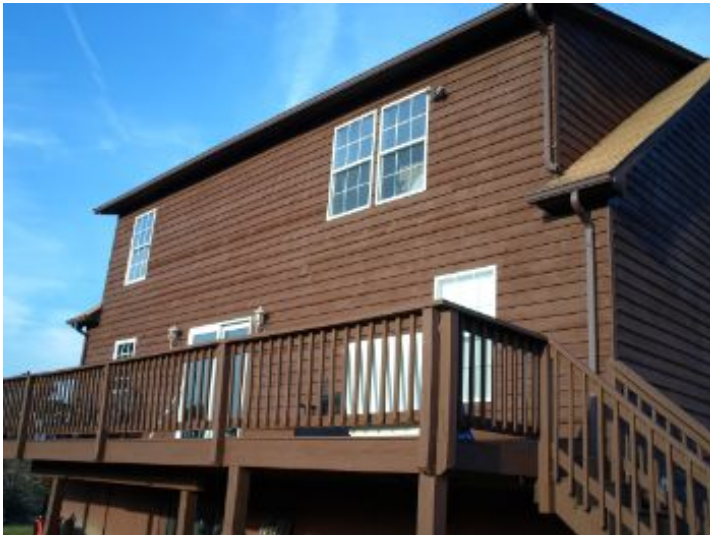
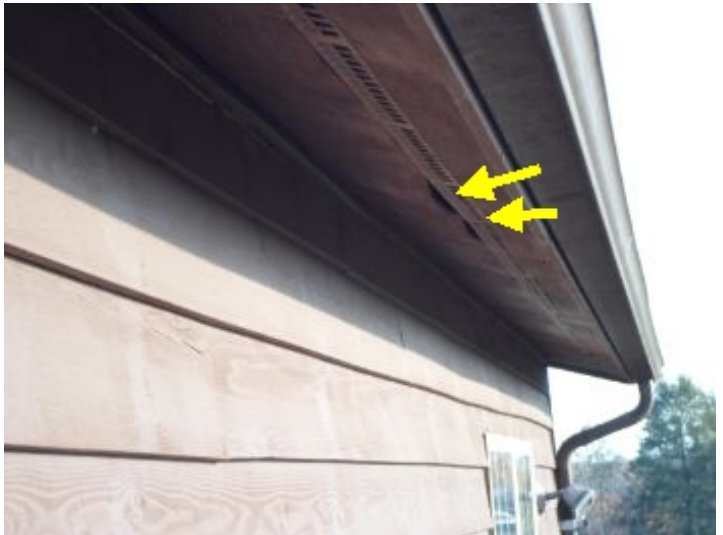
Warping soffits is allowing bees and insects to penetrate into the house.

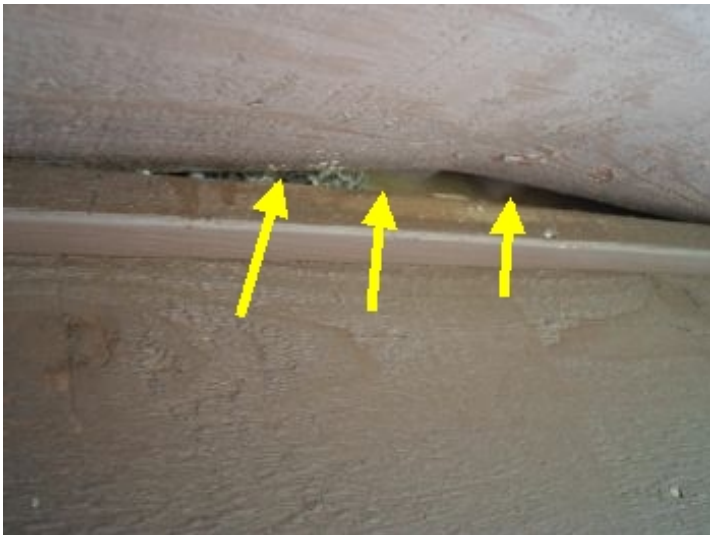
Warping soffits is allowing bees and insects to penetrate into the house.

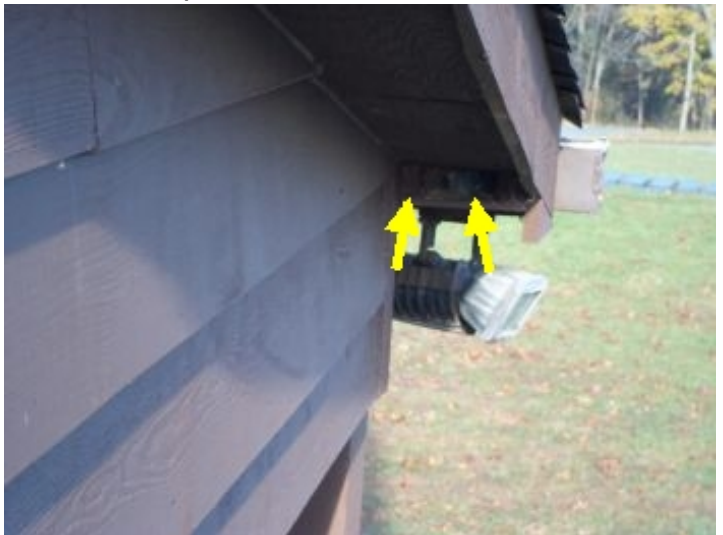
Warping soffits is allowing bees and insects to penetrate into the house.

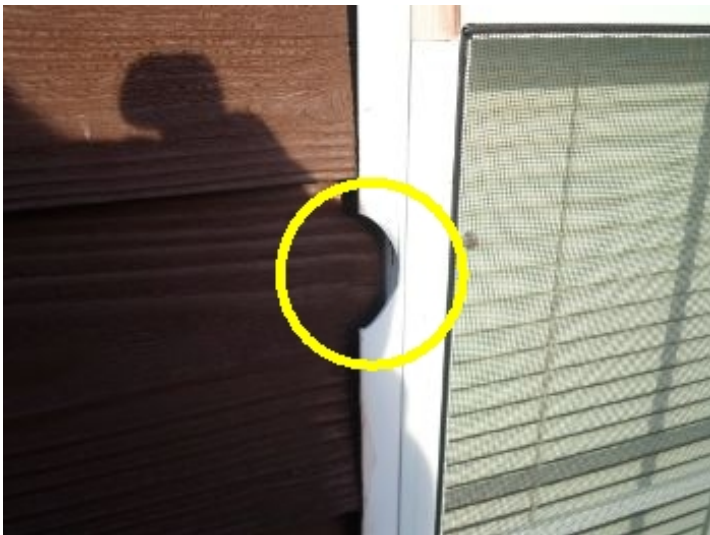
window trim is damaged

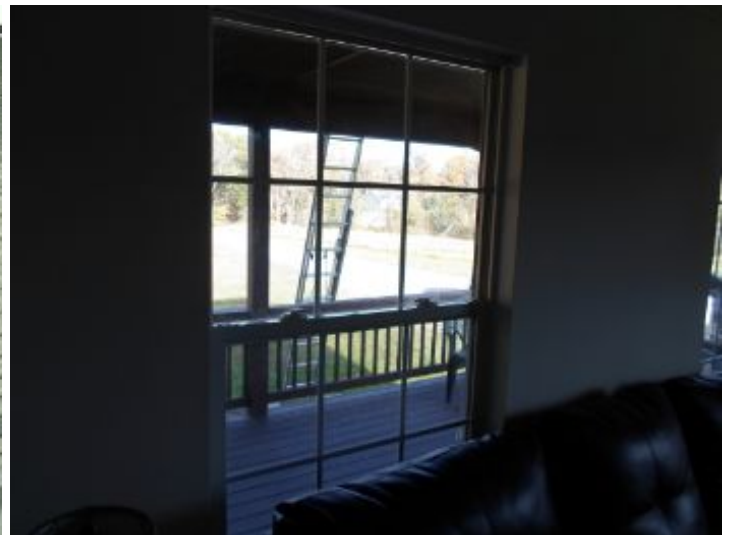
Some windows do not operate as designed.

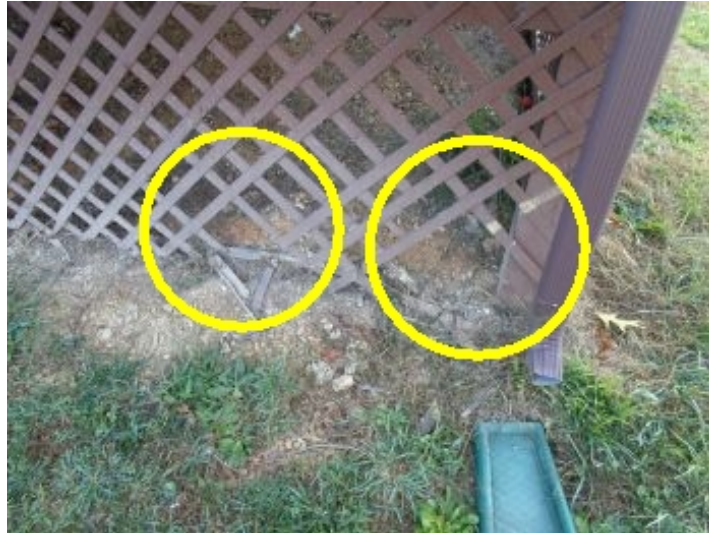
Lattice is broken in some areas.

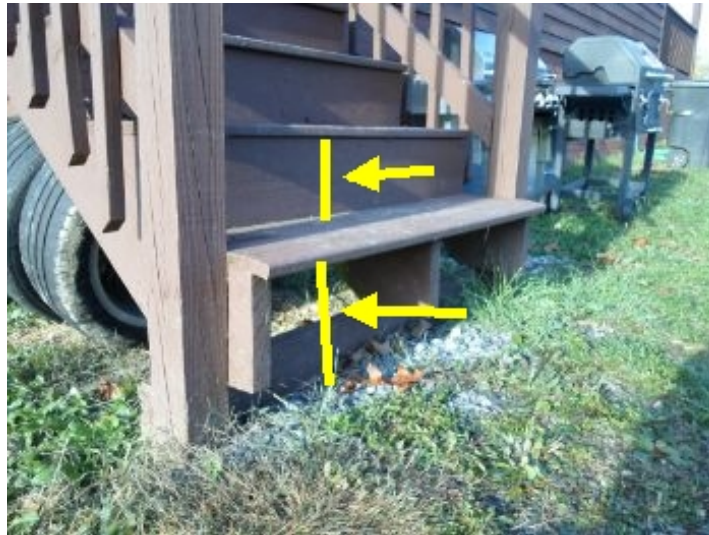
- Deck is bowing down in the middle.
- Bottom step height is higher then all the rest.

Bottom step height is higher then all the rest.

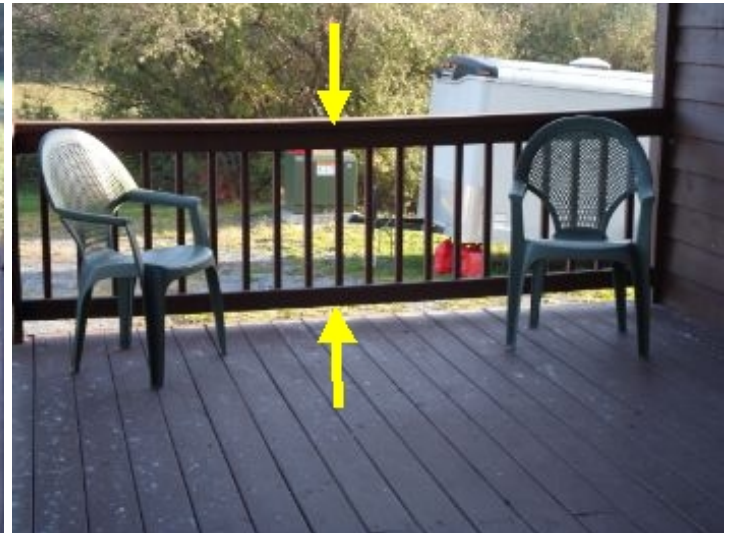
Balusters spaced too far apart.

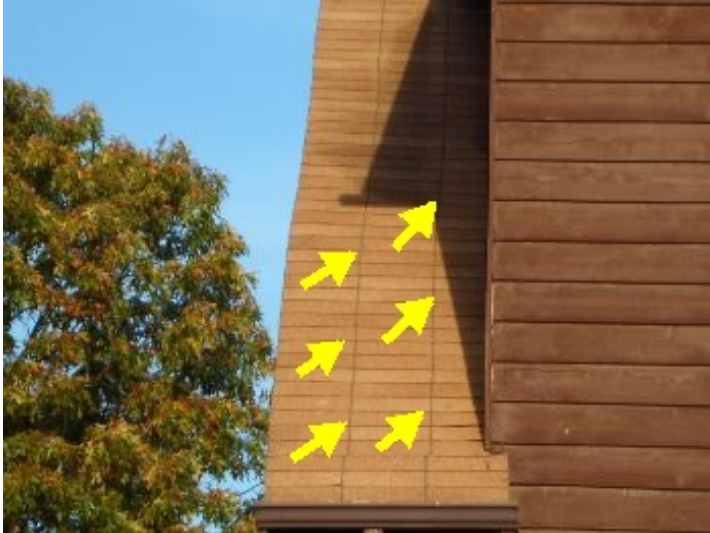
Shingles on rear of home are installed improperly and will eventually leak. They are not staggered as recommended by the manufacturer.

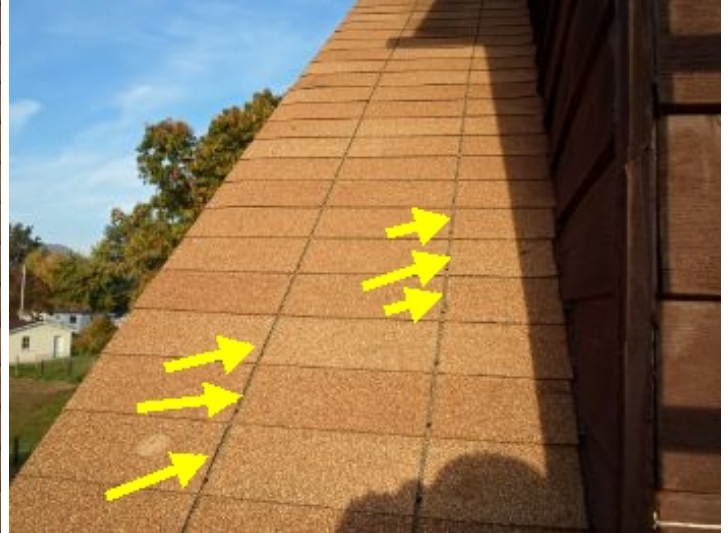
Shingles on rear of home are installed improperly and will eventually leak. They are not staggered as recommended by the manufacturer.

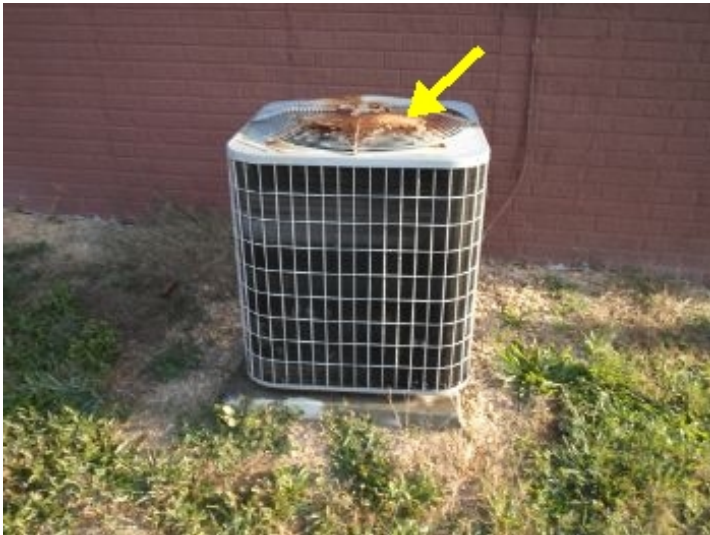
Rust/Stained at exterior condensor.

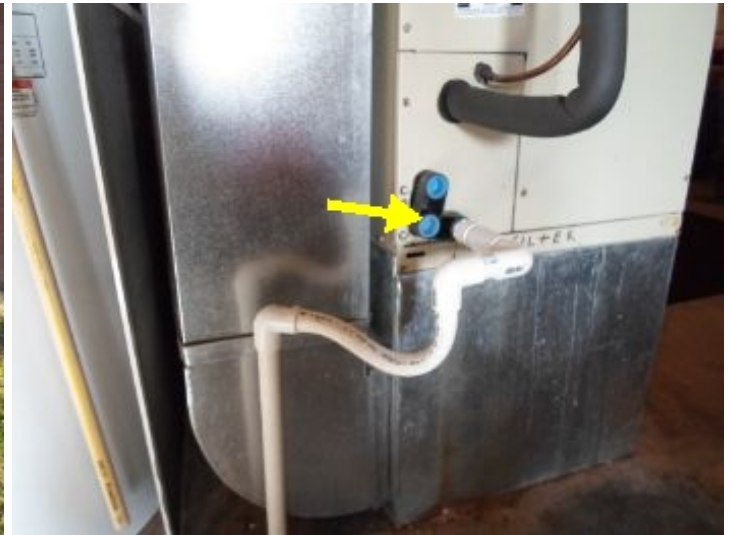
Secondary overflow isn't plumbed and doesn't have an over flow cut off switch.

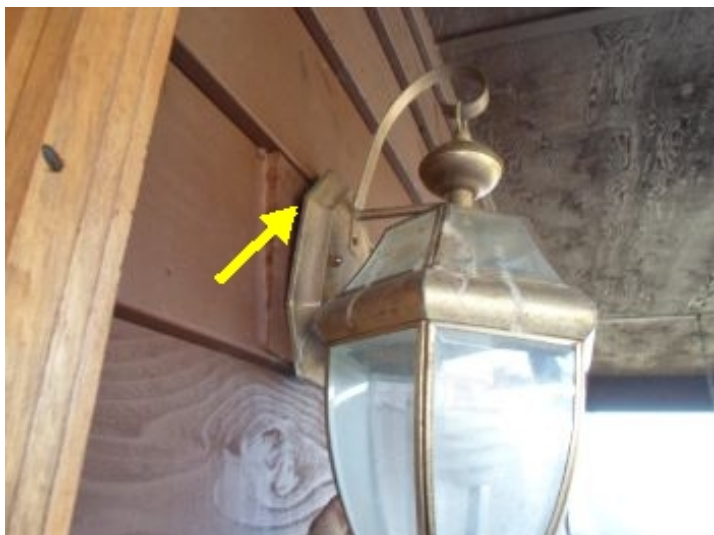
Exterior light fixtures are loose.

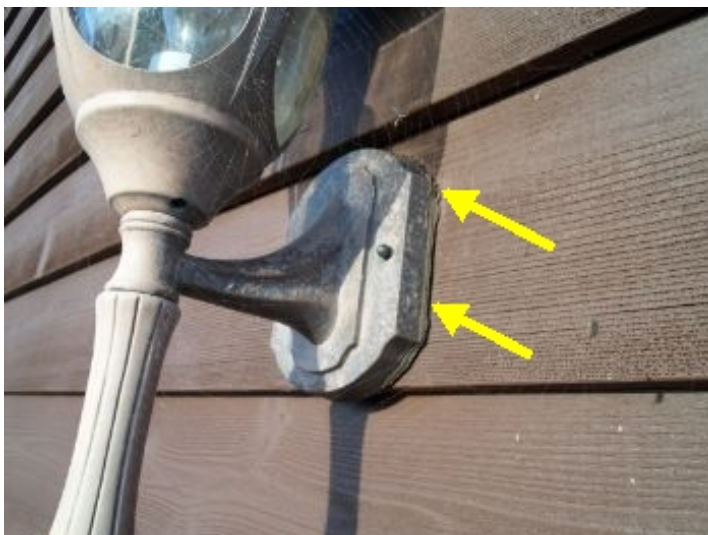
Exterior light fixtures are loose.

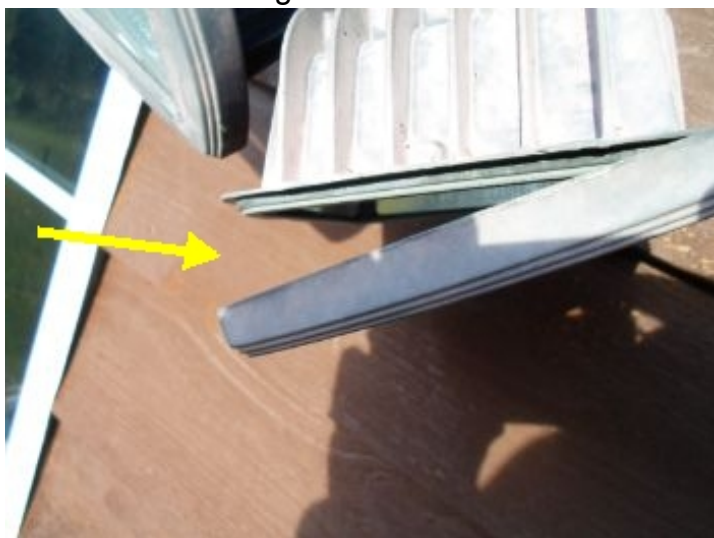
Exterior light fixtures are loose.

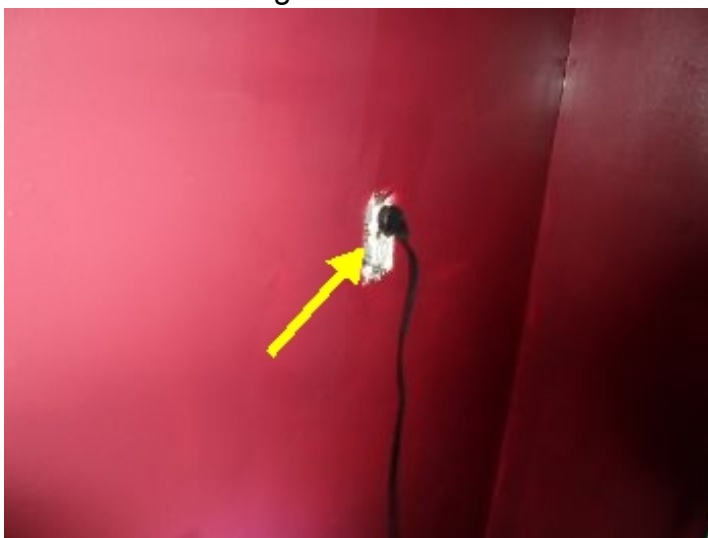
Missing plug cover needs to be fixed.

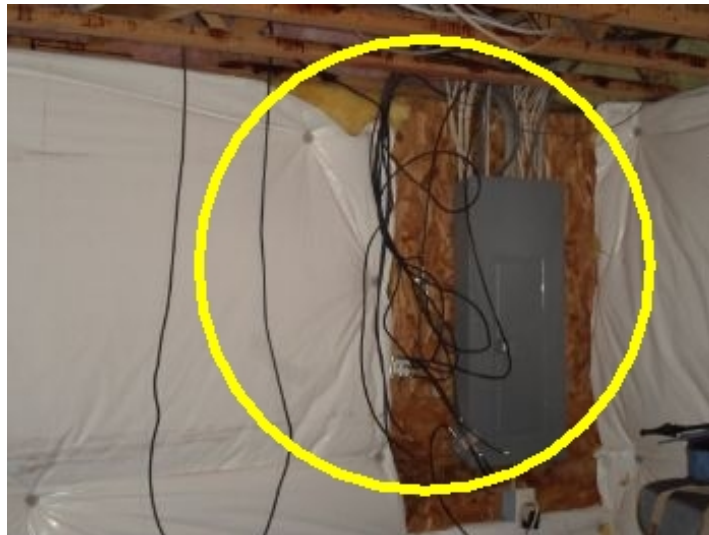
Loose cable/phone wires. Have reviewed.

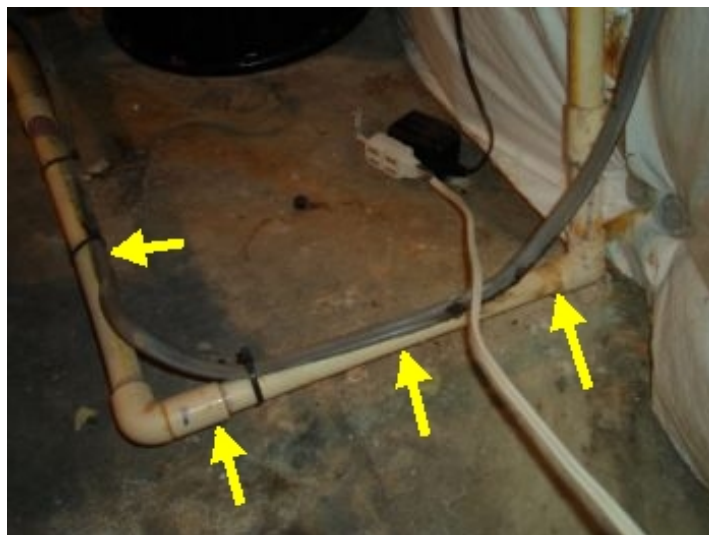
Service pipe from well is unsupported and if stepped on would break off.

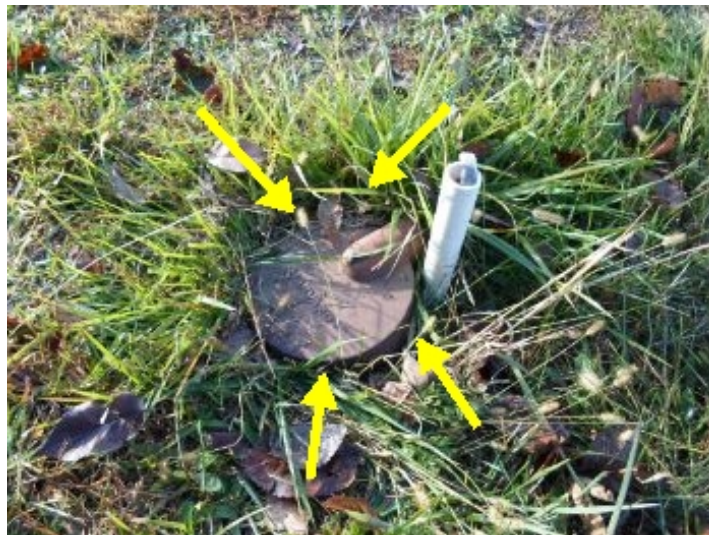
Well pump casing does not come out of the ground high enough. Rain water run off is contaminating the well water.

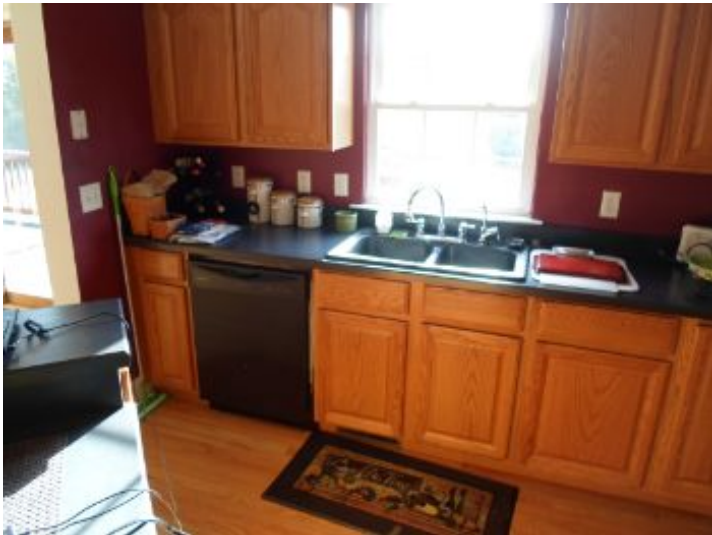
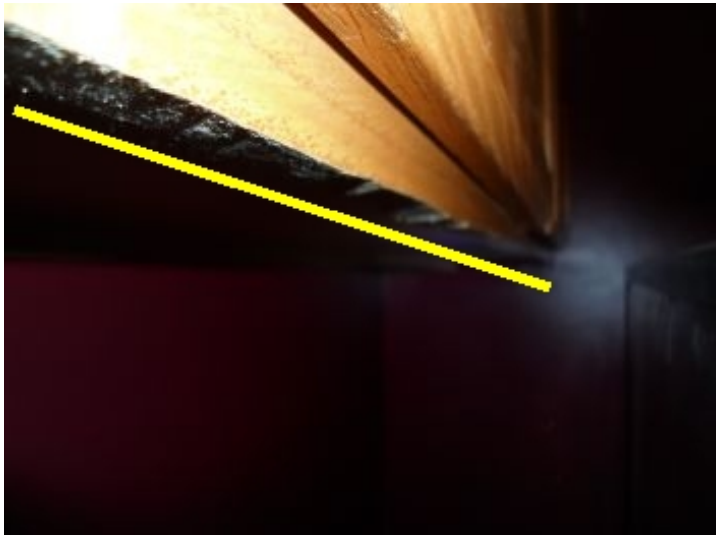
Cabinet over top of the fridge has been chopped up to make it fit.

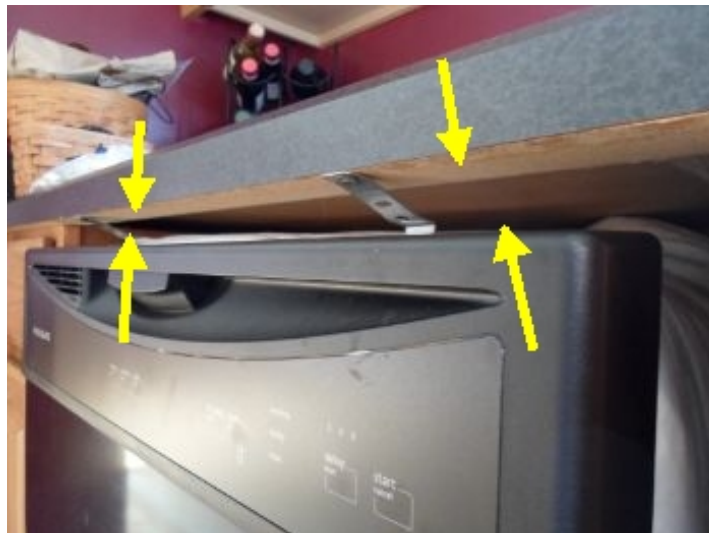
Needs to have the legs adjusted up so that there isn't such a big gap from the counter top.

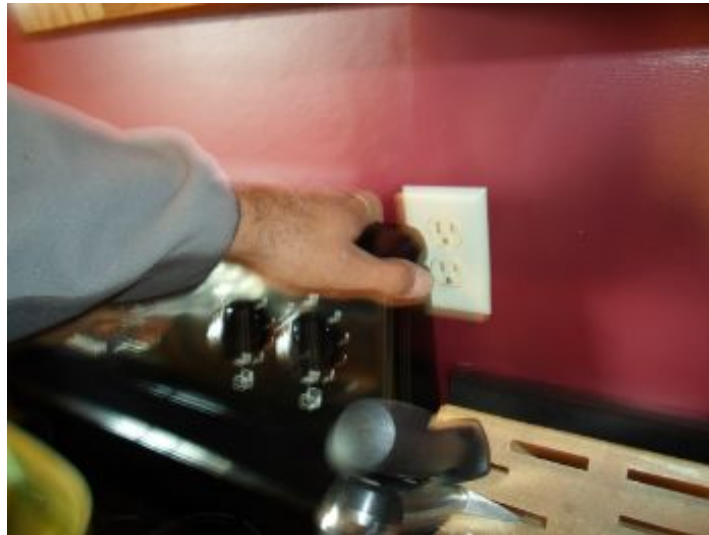
Anti-tip bracket is missing from range installation. See label inside oven door. All free-standing, slide-in ranges include an anti-tip device and is essential in the safe operation of the range. It provides protection when excess force or weight is applied to an open oven door.

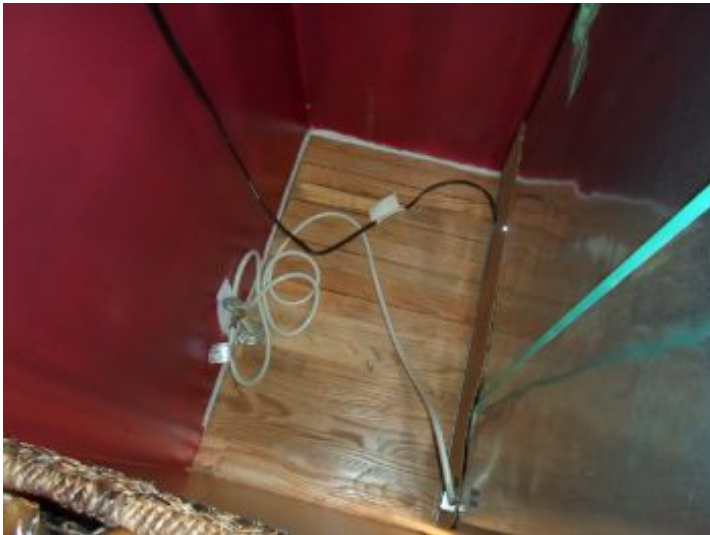
Damaged to the front of the fridge and the water and ice maker feature did not operate when tested.

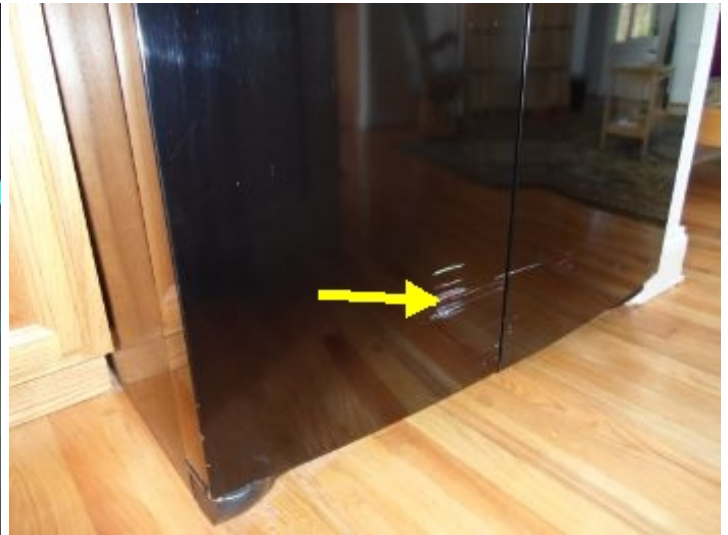
Damaged to the front of the fridge and the water and ice maker feature did not operate when tested.

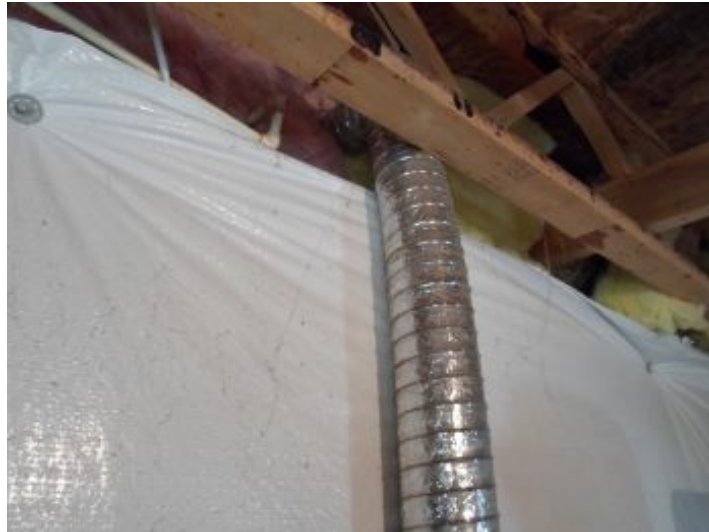
The dryer vent is plastic or foil, accordion-type ducting material. These flexible plastic or foil type duct can more easily trap lint and is more susceptible to kinks or crushing, which can greatly reduce airflow and become overheated. Overheated dryers can cause fires.

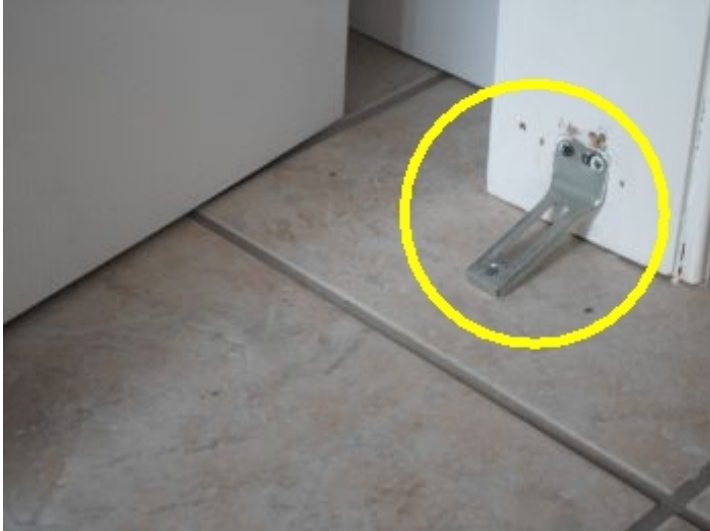
Doors damaged/missing and not installed correctly

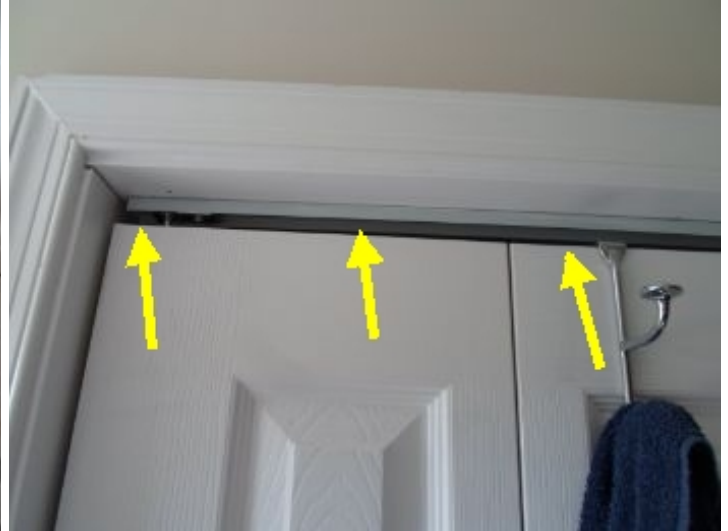
Doors damaged/missing and not installed correctly

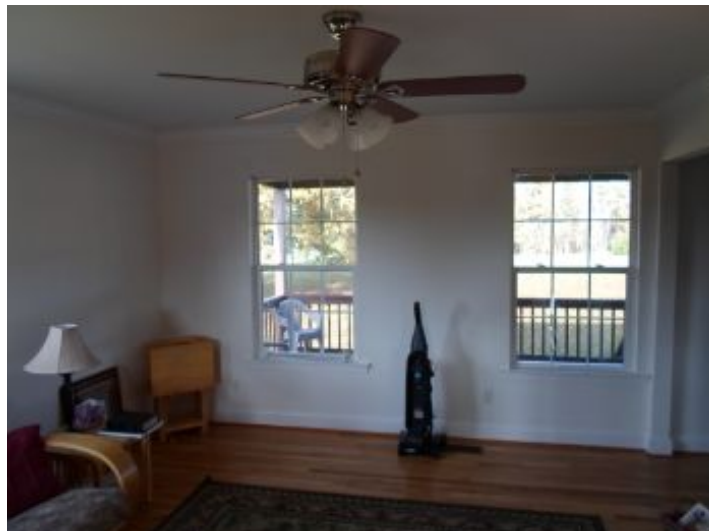
- Does not open and close properly on multiple windows throughout the house.

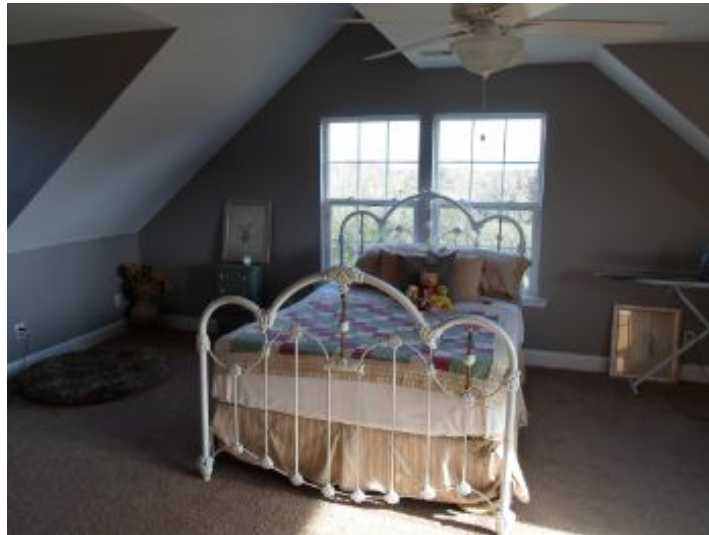
Some paint and drywall touch up needed.

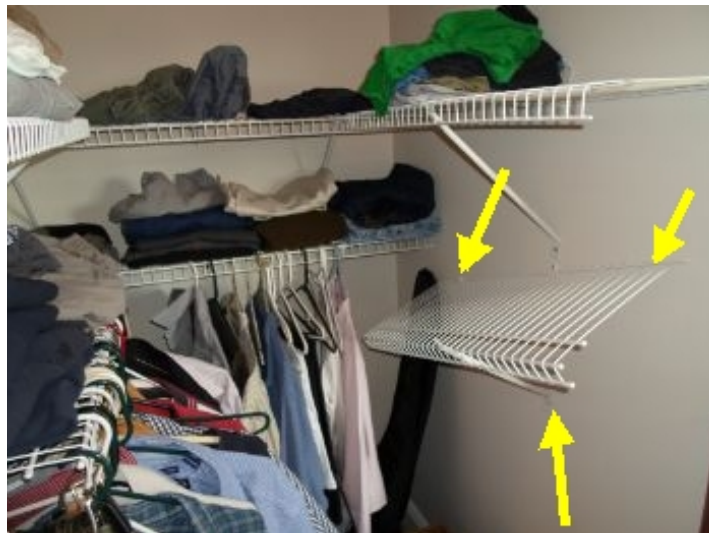
Shelves in closet damaged/missing

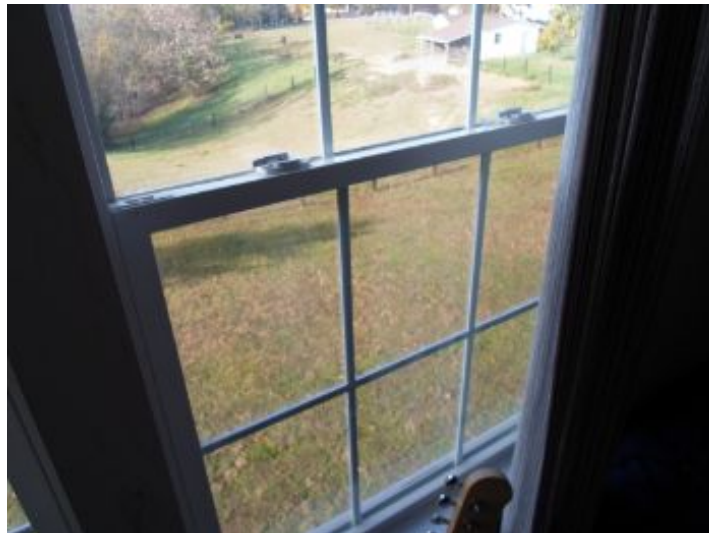
Does not operate properly

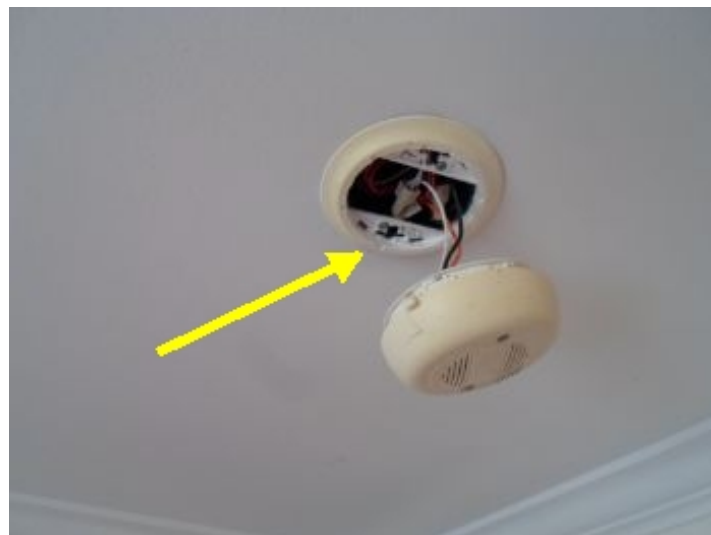
Smoke detector is loose and hanging from the wires.

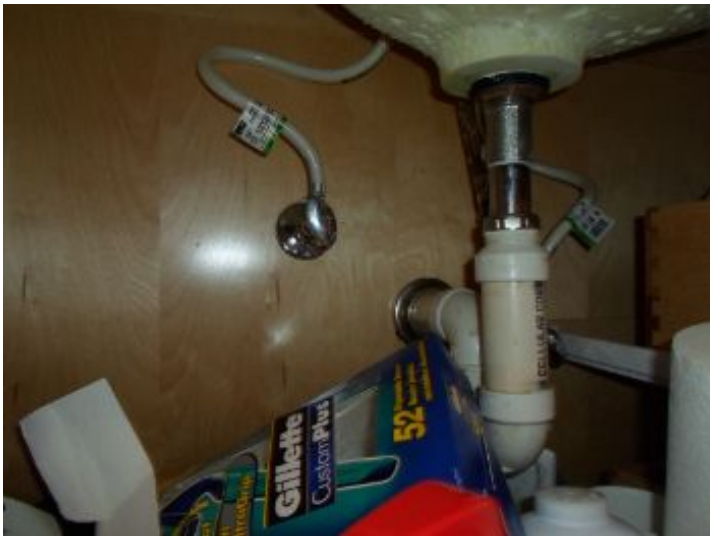
Sink drained slow

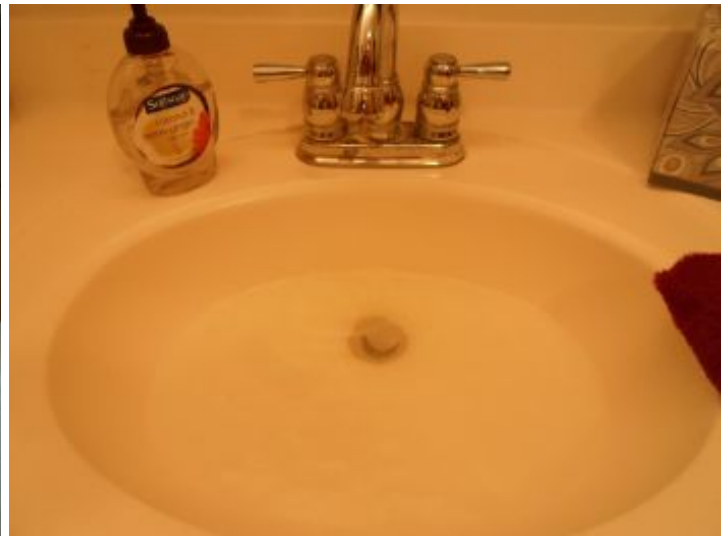
Sink drained slow

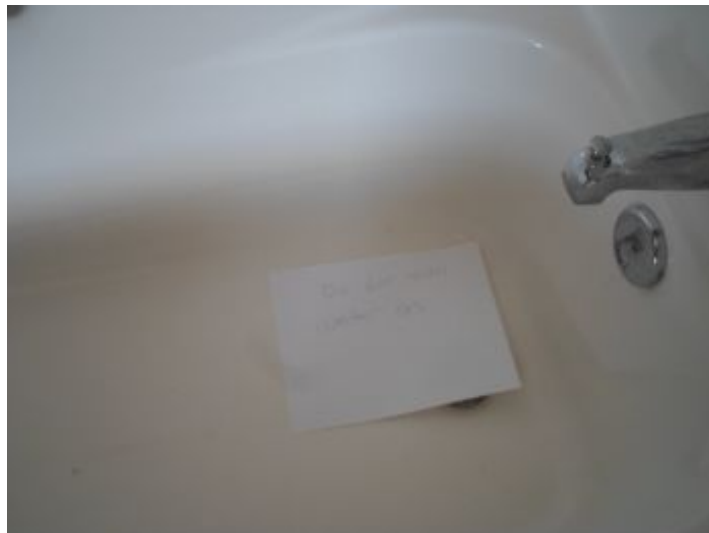
Could not test due to sign that says do not run water. Moisture stains observed on the ceiling below second floor tub.
