# ***Passmore Contracting Inspections***

## **Property Inspection Report**

1234 Sample Rd, Sample, VA 22222  
Inspection prepared for: Brian Passmore  
Date of Inspection: 10/27/2013 Time: 0900  
Age of Home: 2001 Size: 1960  
Weather: Clear 40 Deg.  
\$350 Paid Cash

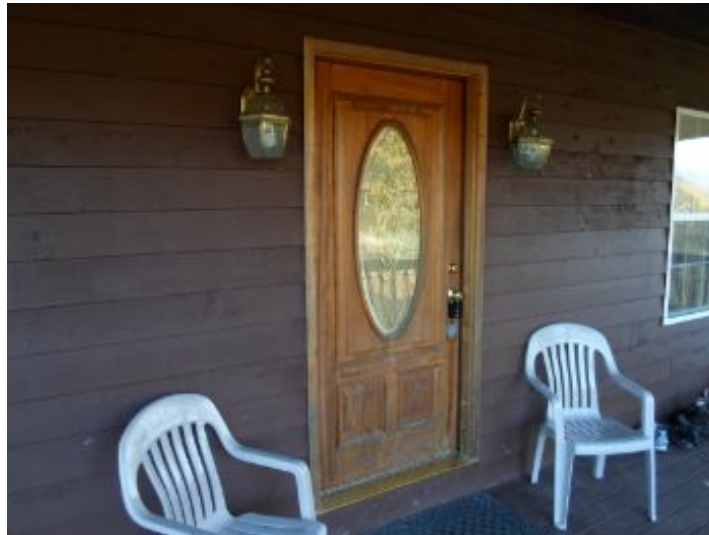
Appear in functional and in satisfactory condition, at time of inspection.

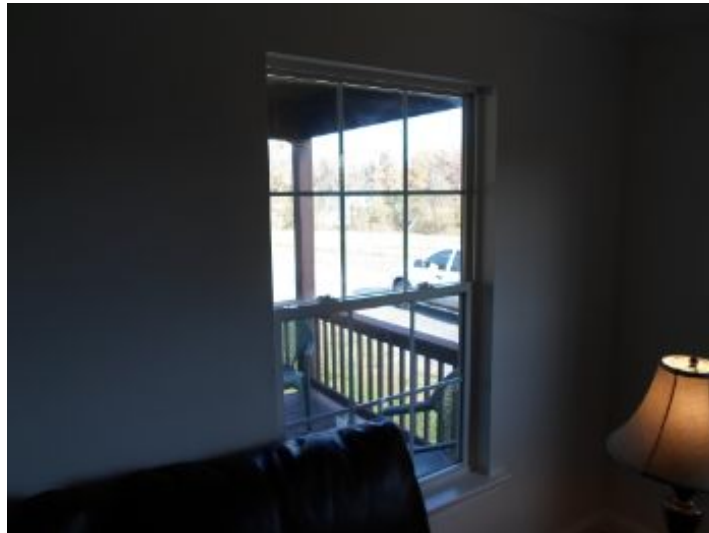
Some windows do not operate as designed.

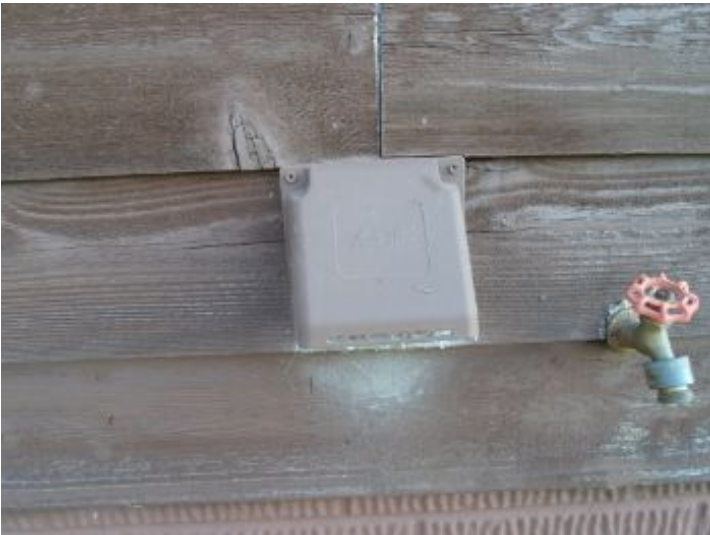
Appeared functional at time of inspection

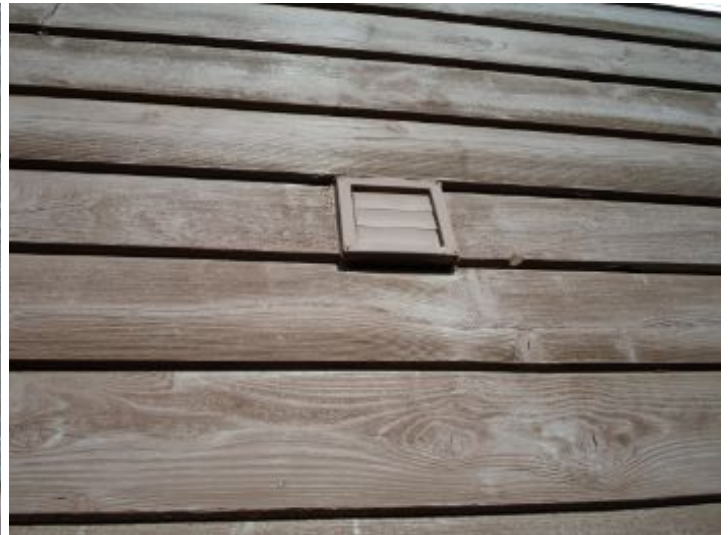
Appeared functional at time of inspection

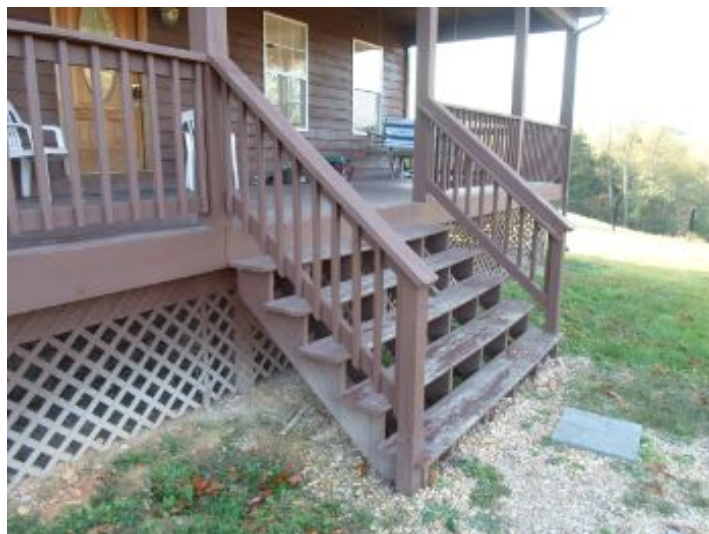
Appeared functional, at time of inspection.

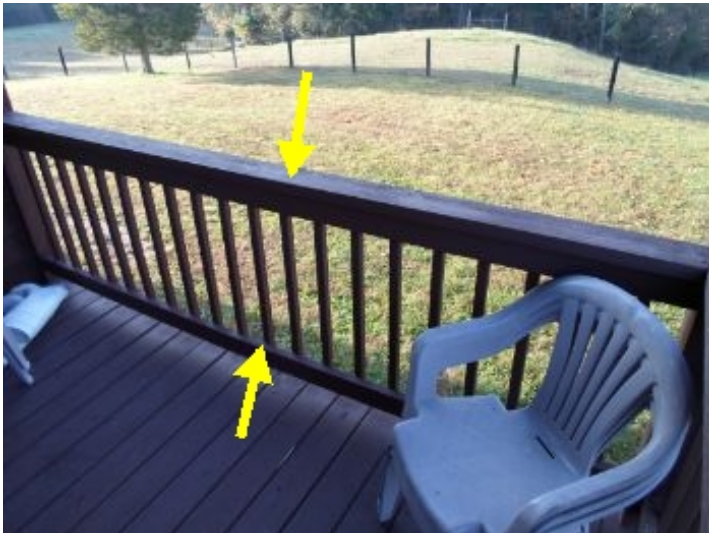
Balusters spaced too far apart.

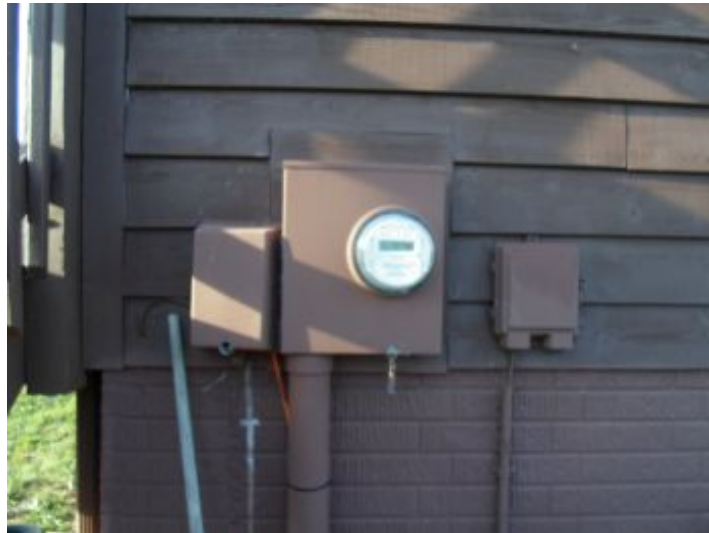
Appeared functional and serviceable, at time of inspection.

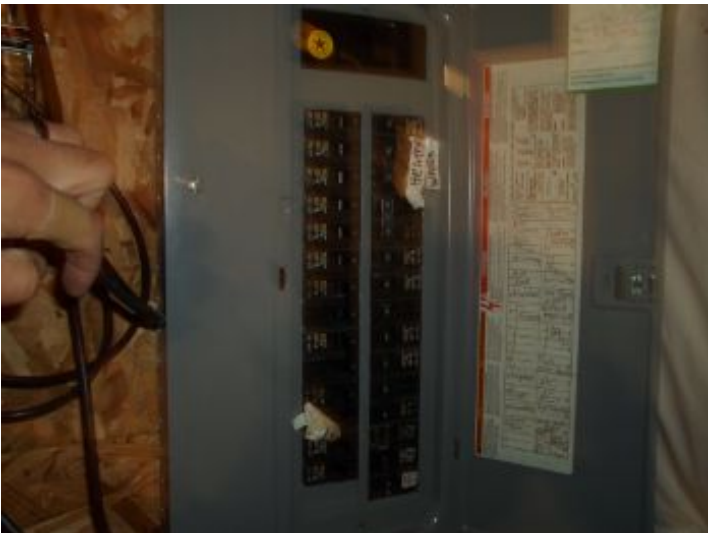
The wiring within the panel appeared satisfactory and functional, at time of inspection.

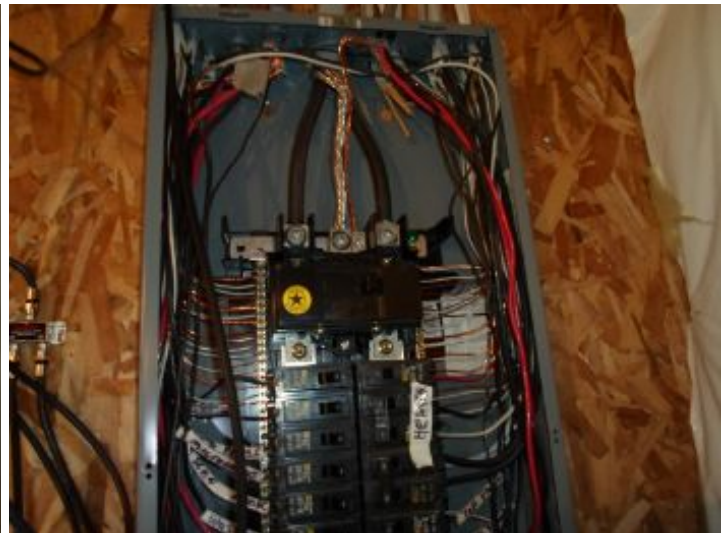
The wiring within the panel appeared satisfactory and functional, at time of inspection.

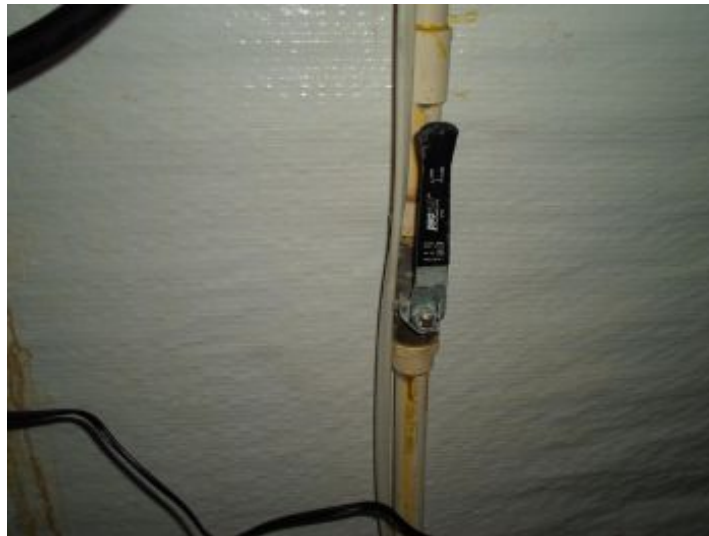
Appeared functional at time of inspection.

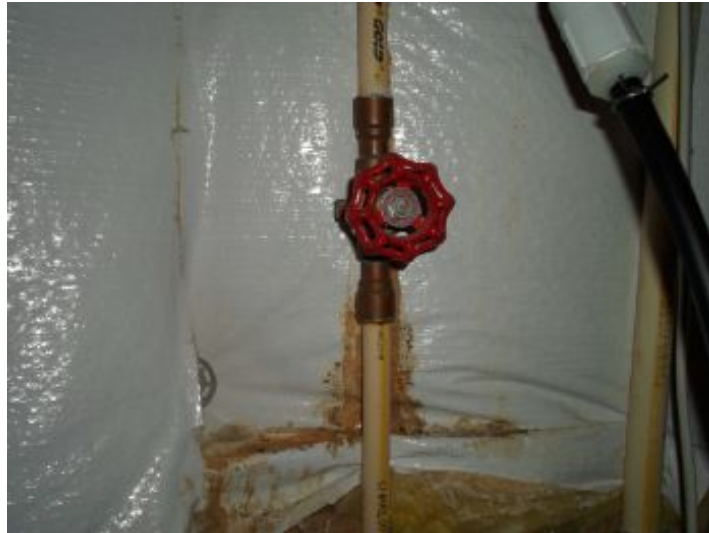
Appeared functional at time of inspection.

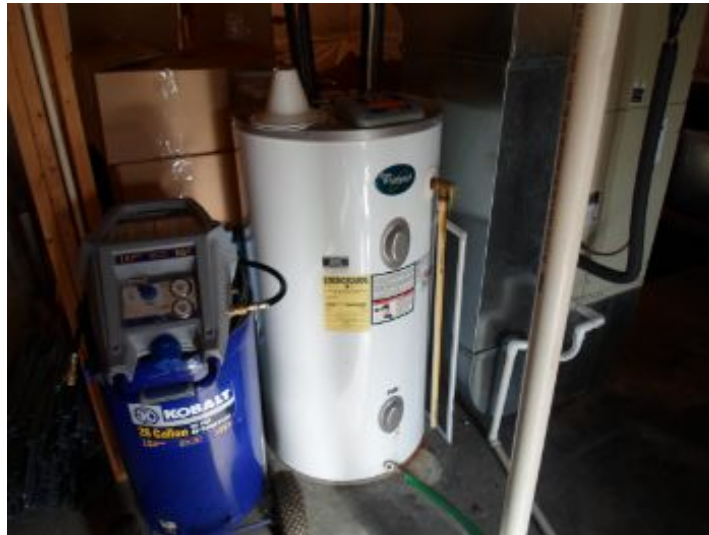
Appears to be in satisfactory condition -- no concerns.

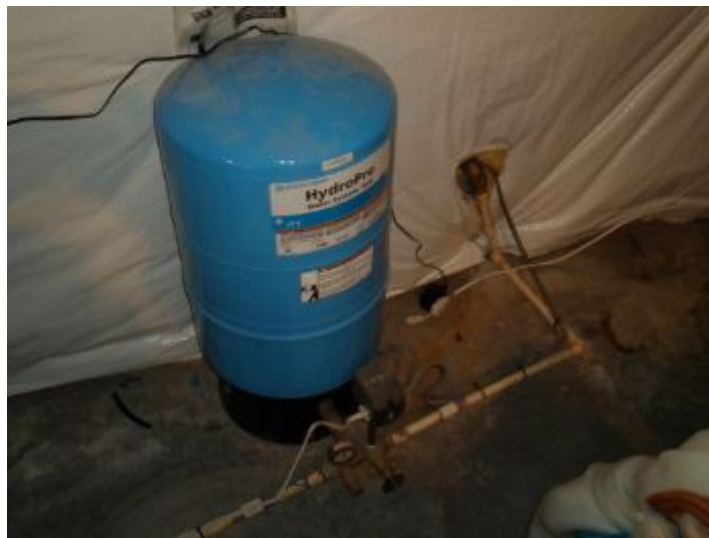
Appeared functional at time of inspection.

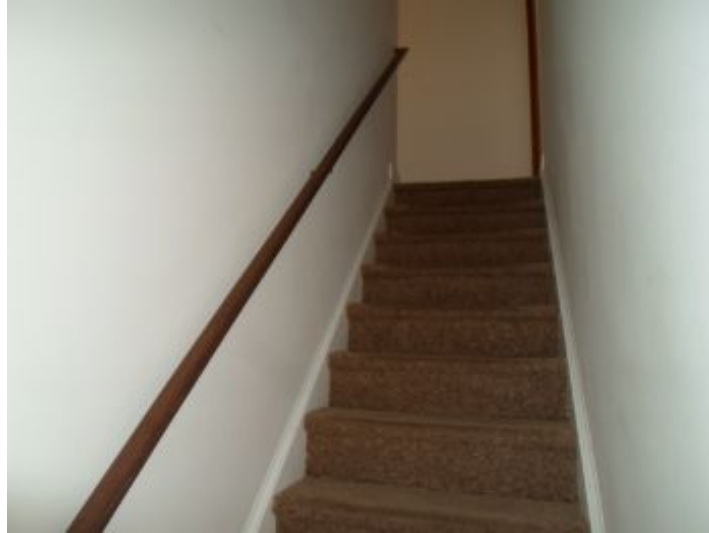
Appeared functional, at time of inspection.

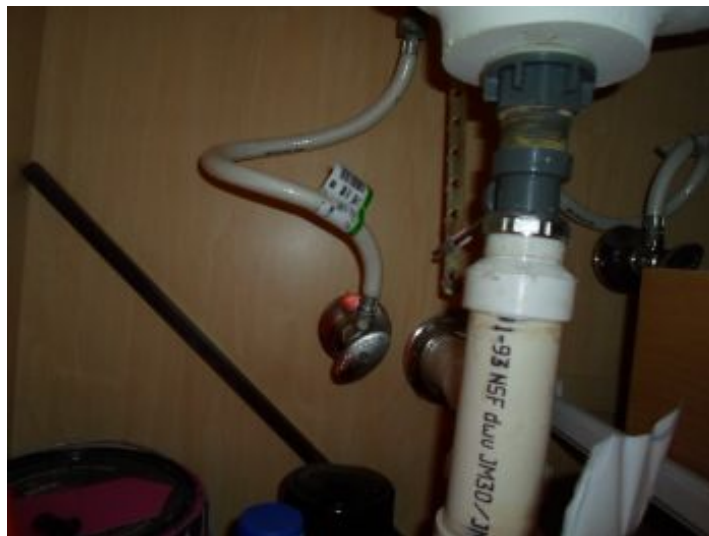
Water was run through the fixtures and drains. Functional flow was observed. Functional drainage was observed.

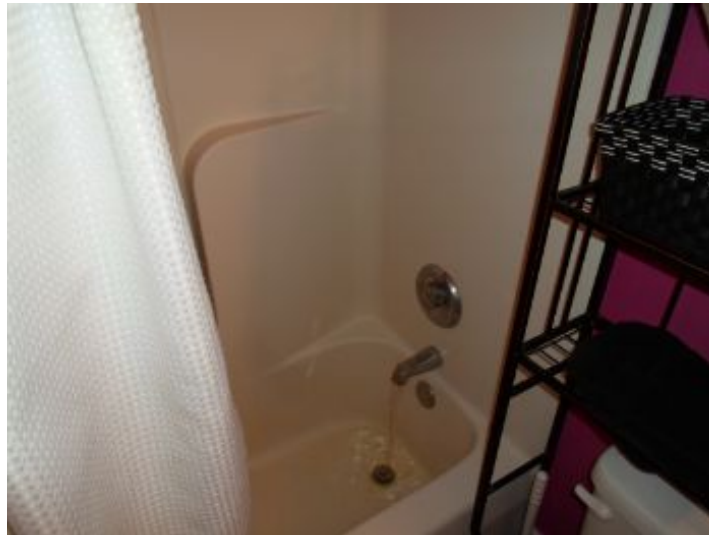
Appeared satisfactory and functional, at time of inspection.

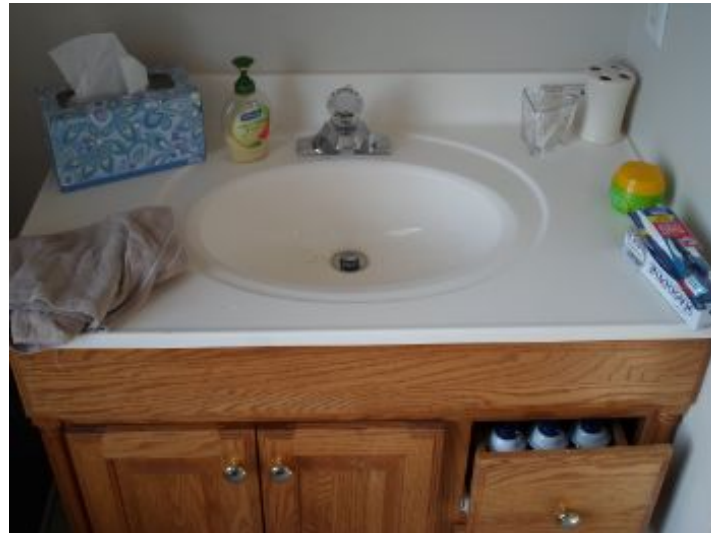
Appeared functional, at time of inspection.

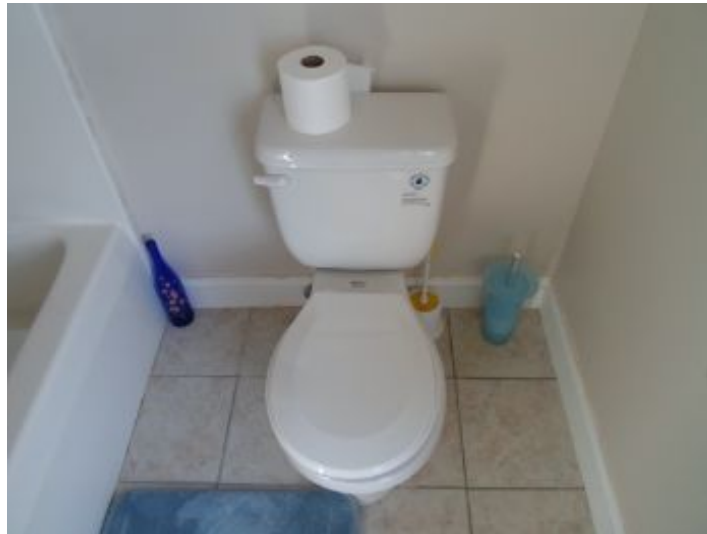
Operated when tested. Appeared functional, at time of inspection.
