# ***Passmore Contracting Inspections***

## **Property Inspection Report**

1234 Sample Rd, Sample, VA 22222  
Inspection prepared for: Brian Passmore  
Date of Inspection: 10/27/2013 Time: 0900  
Age of Home: 2001 Size: 1960  
Weather: Clear 40 Deg.  
\$350 Paid Cash

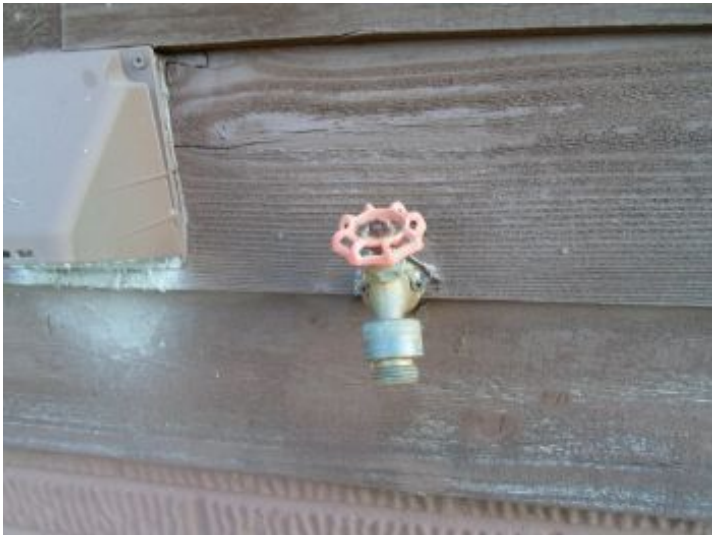
Operated properly when tested

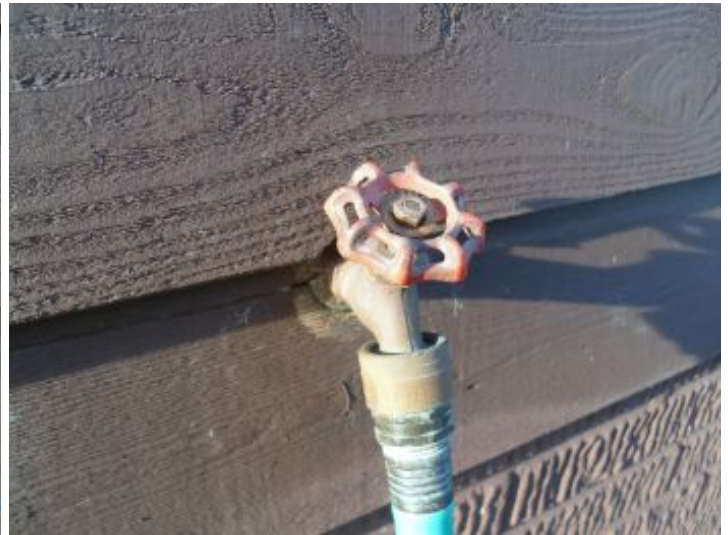
Operated properly when tested

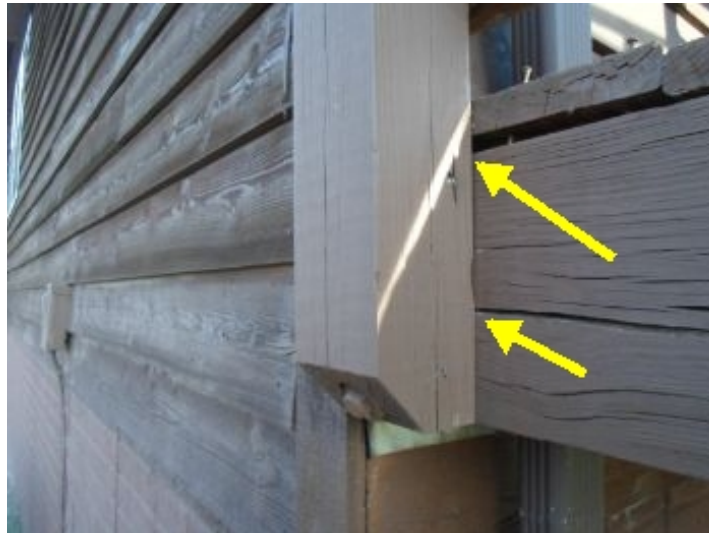
Unstable railings

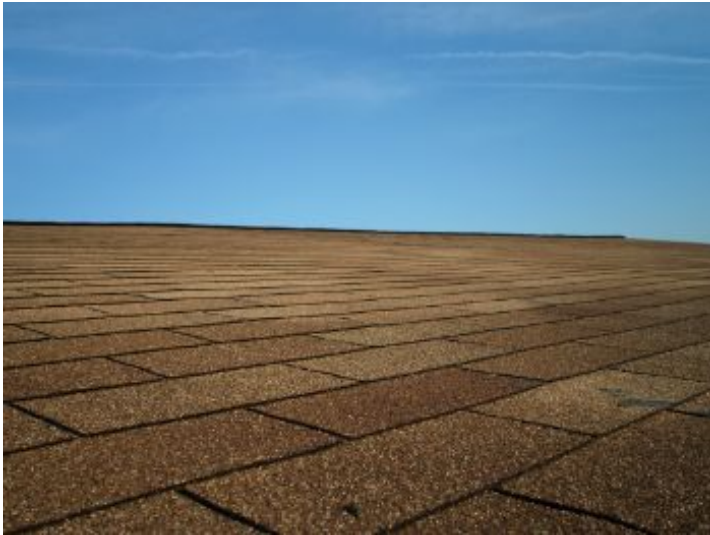
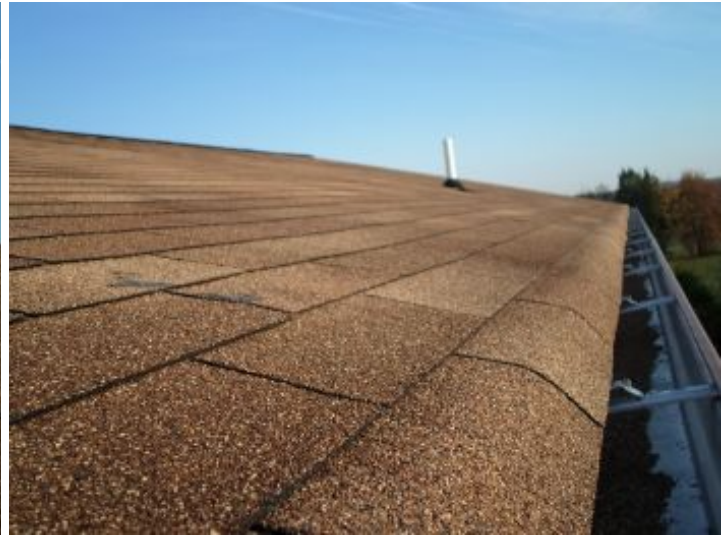
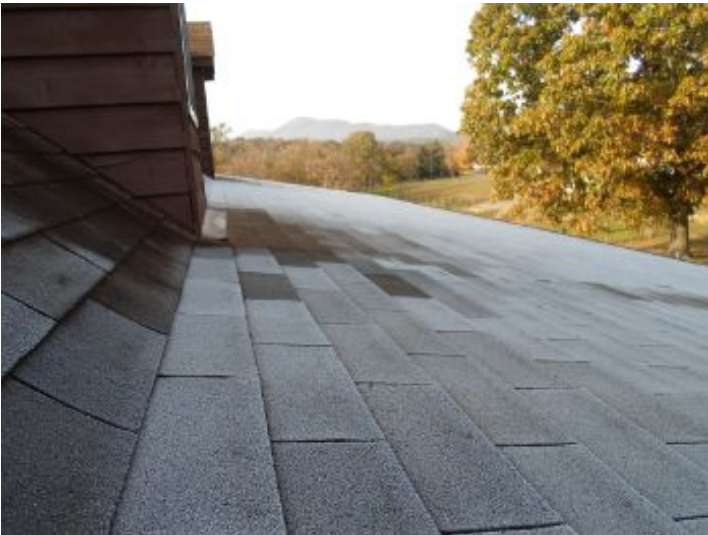
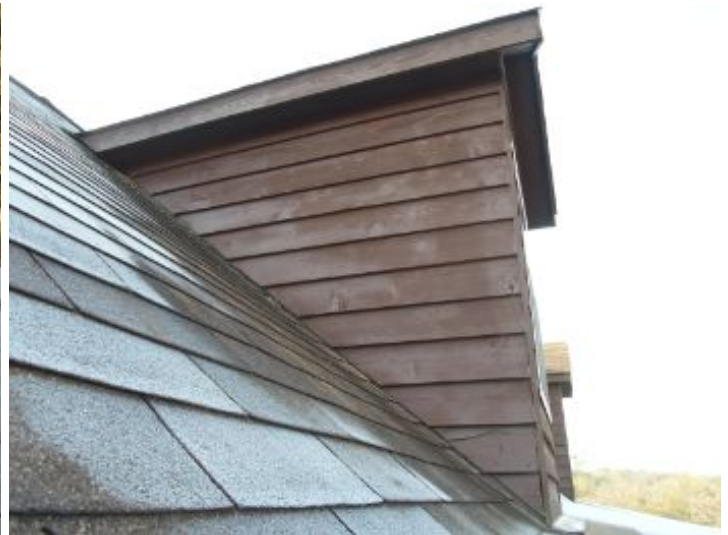
Shingles on rear of home are installed improperly and will eventually leak. They are not staggered as recommended by the manufacturer.

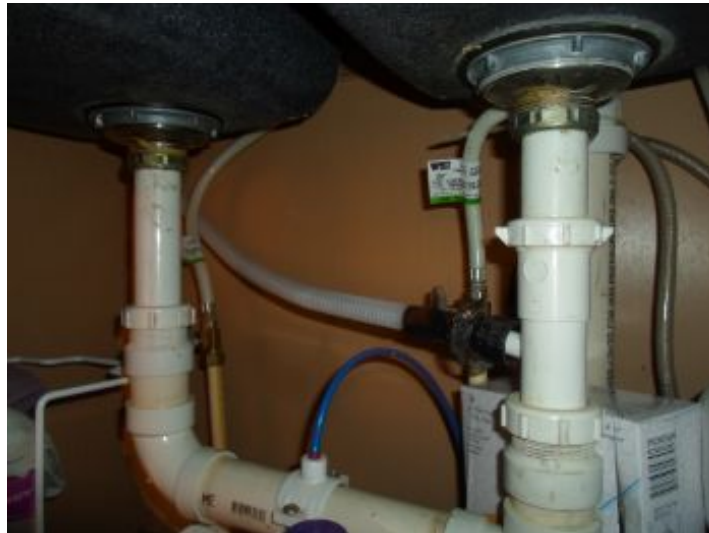
Components appeared satisfactory with no leaks, at time of inspection.

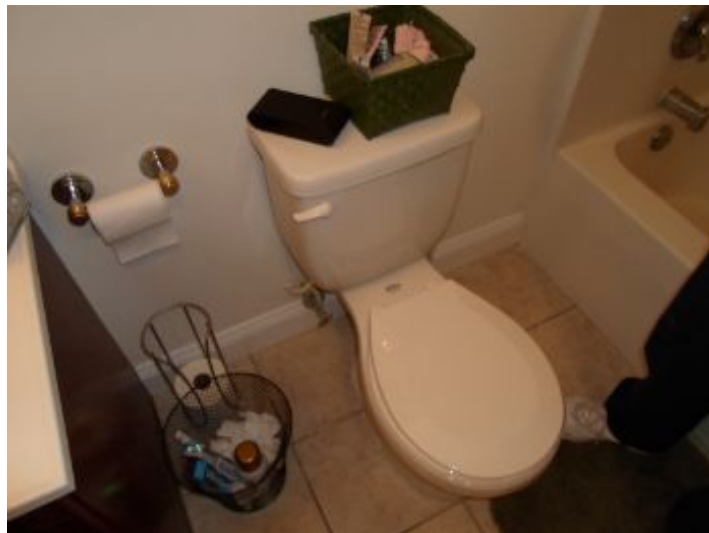
Operated when tested. Appeared functional, at time of inspection.

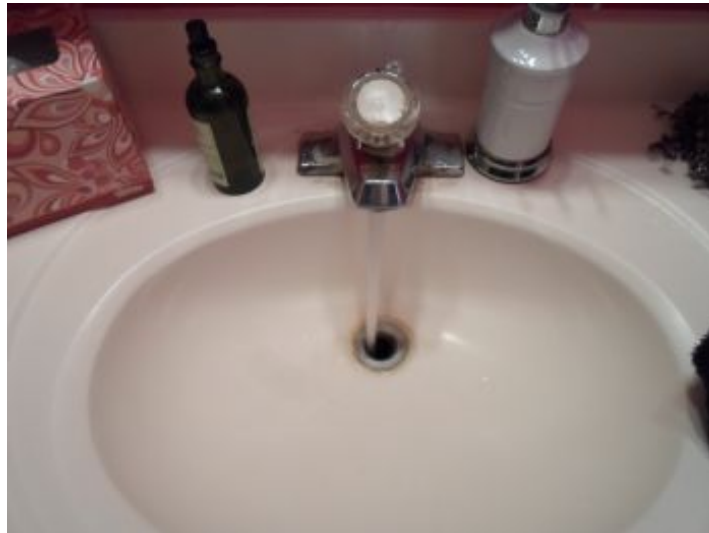
Appeared satisfactory and functional, at time of inspection.

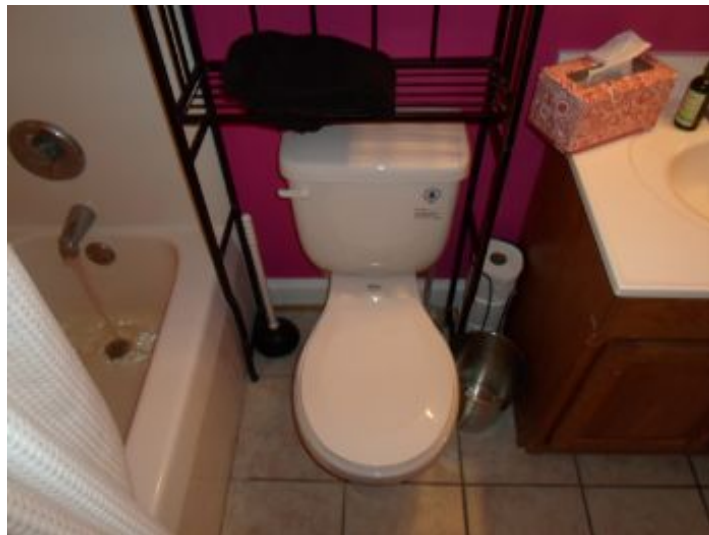
Operated when tested. Appeared functional, at time of inspection.

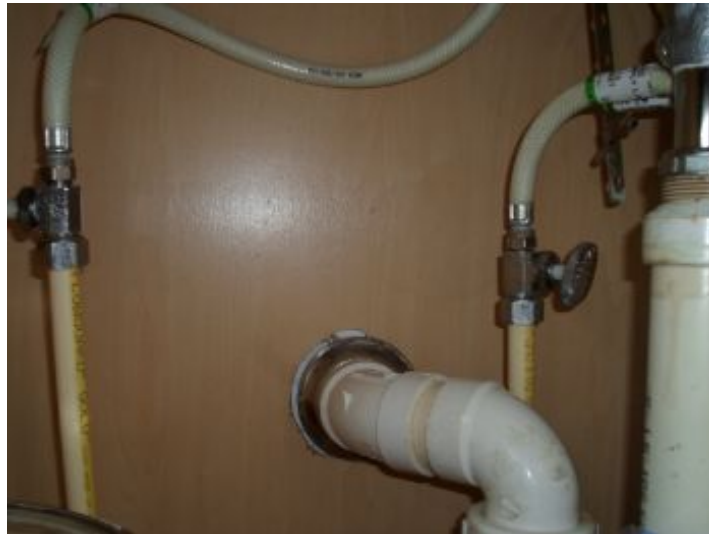
Water was run through the fixtures and drains. Functional flow was observed. Functional drainage was observed.
